# Manhole Inspection Summary

Manhole # S55E\_\_013MH

**Location** Address: **rear 110 s conkling st**

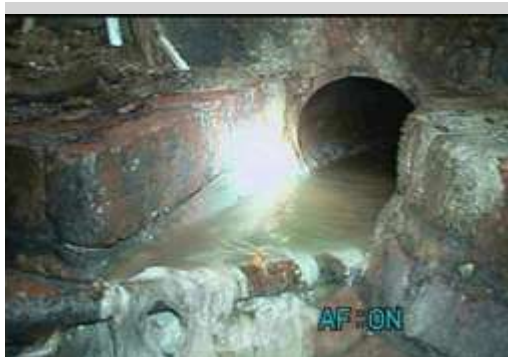
misc channel debris

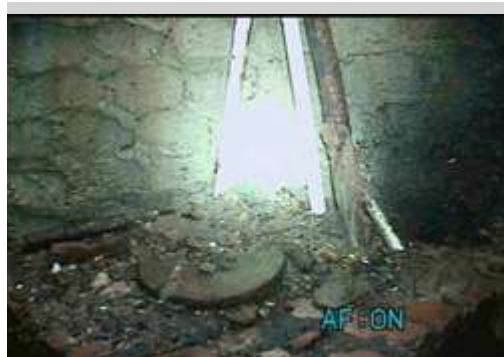
misc bench debris

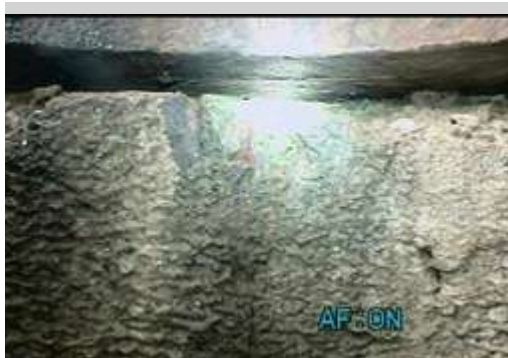
Defect 2

**Chimney / Frame Adjustment** ☒ Exists Material: **Brick and Concrete** ☐ Parged Height: **2.5** (in.)

Condition: ☐ Sound ☐ Cracked ☐ Root Intrusion ☒ **Loose Brick** ☒ **Deteriorated**

frame adj; loose bricks and deteriorating chimney

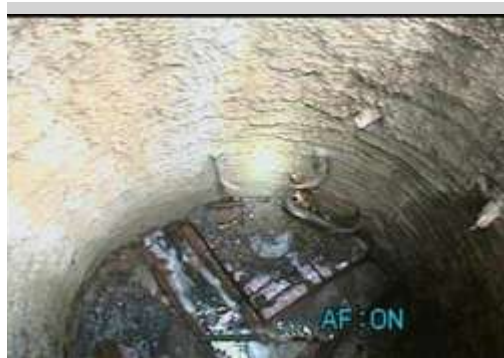
Defect 1

Condition: ☐ Sound ☐ Cracked ☐ Root Intrusion ☐ Loose Brick ☒ **Deteriorated**

**Steps** Count: **3** Missing: **2** ☒ **Corroded**

corroded/missing steps, corbel deteriorating

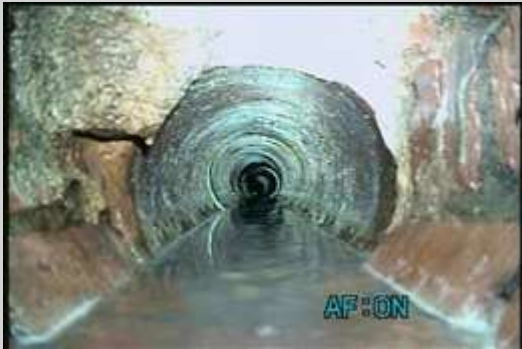
12 O'Clock Outflow

8 in. Circular Gravity Sewer  
Pipe Out @ 12 O'Clock

Pipe Material: **Clay** ☐ Pipe Lined

Invert Depth: 7.63 (ft.) Flow Characteristics: **Fast**

Deposits: ☒ None ☐ Mud ☐ Sludge ☐ Debris ☐ Grease

Infiltration: **None** Pipe Seal Cond: **Unknown**

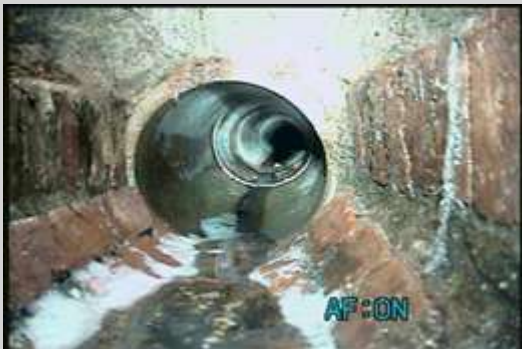
6 O'Clock Inflow

8 in. Circular Gravity Sewer  
Pipe In @ 6 O'Clock

Pipe Material: **Clay** ☐ Pipe Lined

Invert Depth: 7.60 (ft.) Flow Characteristics: **None**

Deposits: ☒ None ☐ Mud ☐ Sludge ☐ Debris ☐ Grease

Infiltration: **None** Pipe Seal Cond: **Unknown**

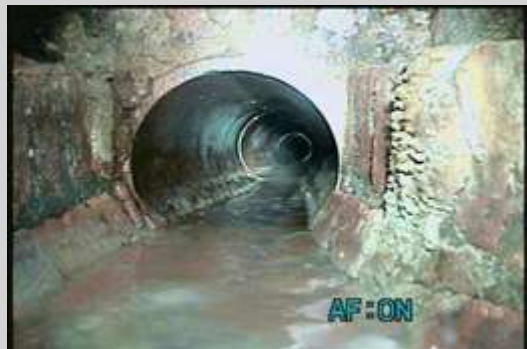
9 O'Clock Inflow

8 in. Circular Gravity Sewer  
Pipe In @ 9 O'Clock

Pipe Material: **Clay** ☐ Pipe Lined

Invert Depth: **7.49** (ft.) Flow Characteristics: **Fast**

Deposits: ☒ None ☐ Mud ☐ Sludge ☐ Debris ☐ Grease

Infiltration: **None** Pipe Seal Cond: **Unknown**
